Memorandum

Date: June 16, 2021

Re: Wild Meadows Drainage Assessment – Medina, MN
WSB Project No. 017741-000

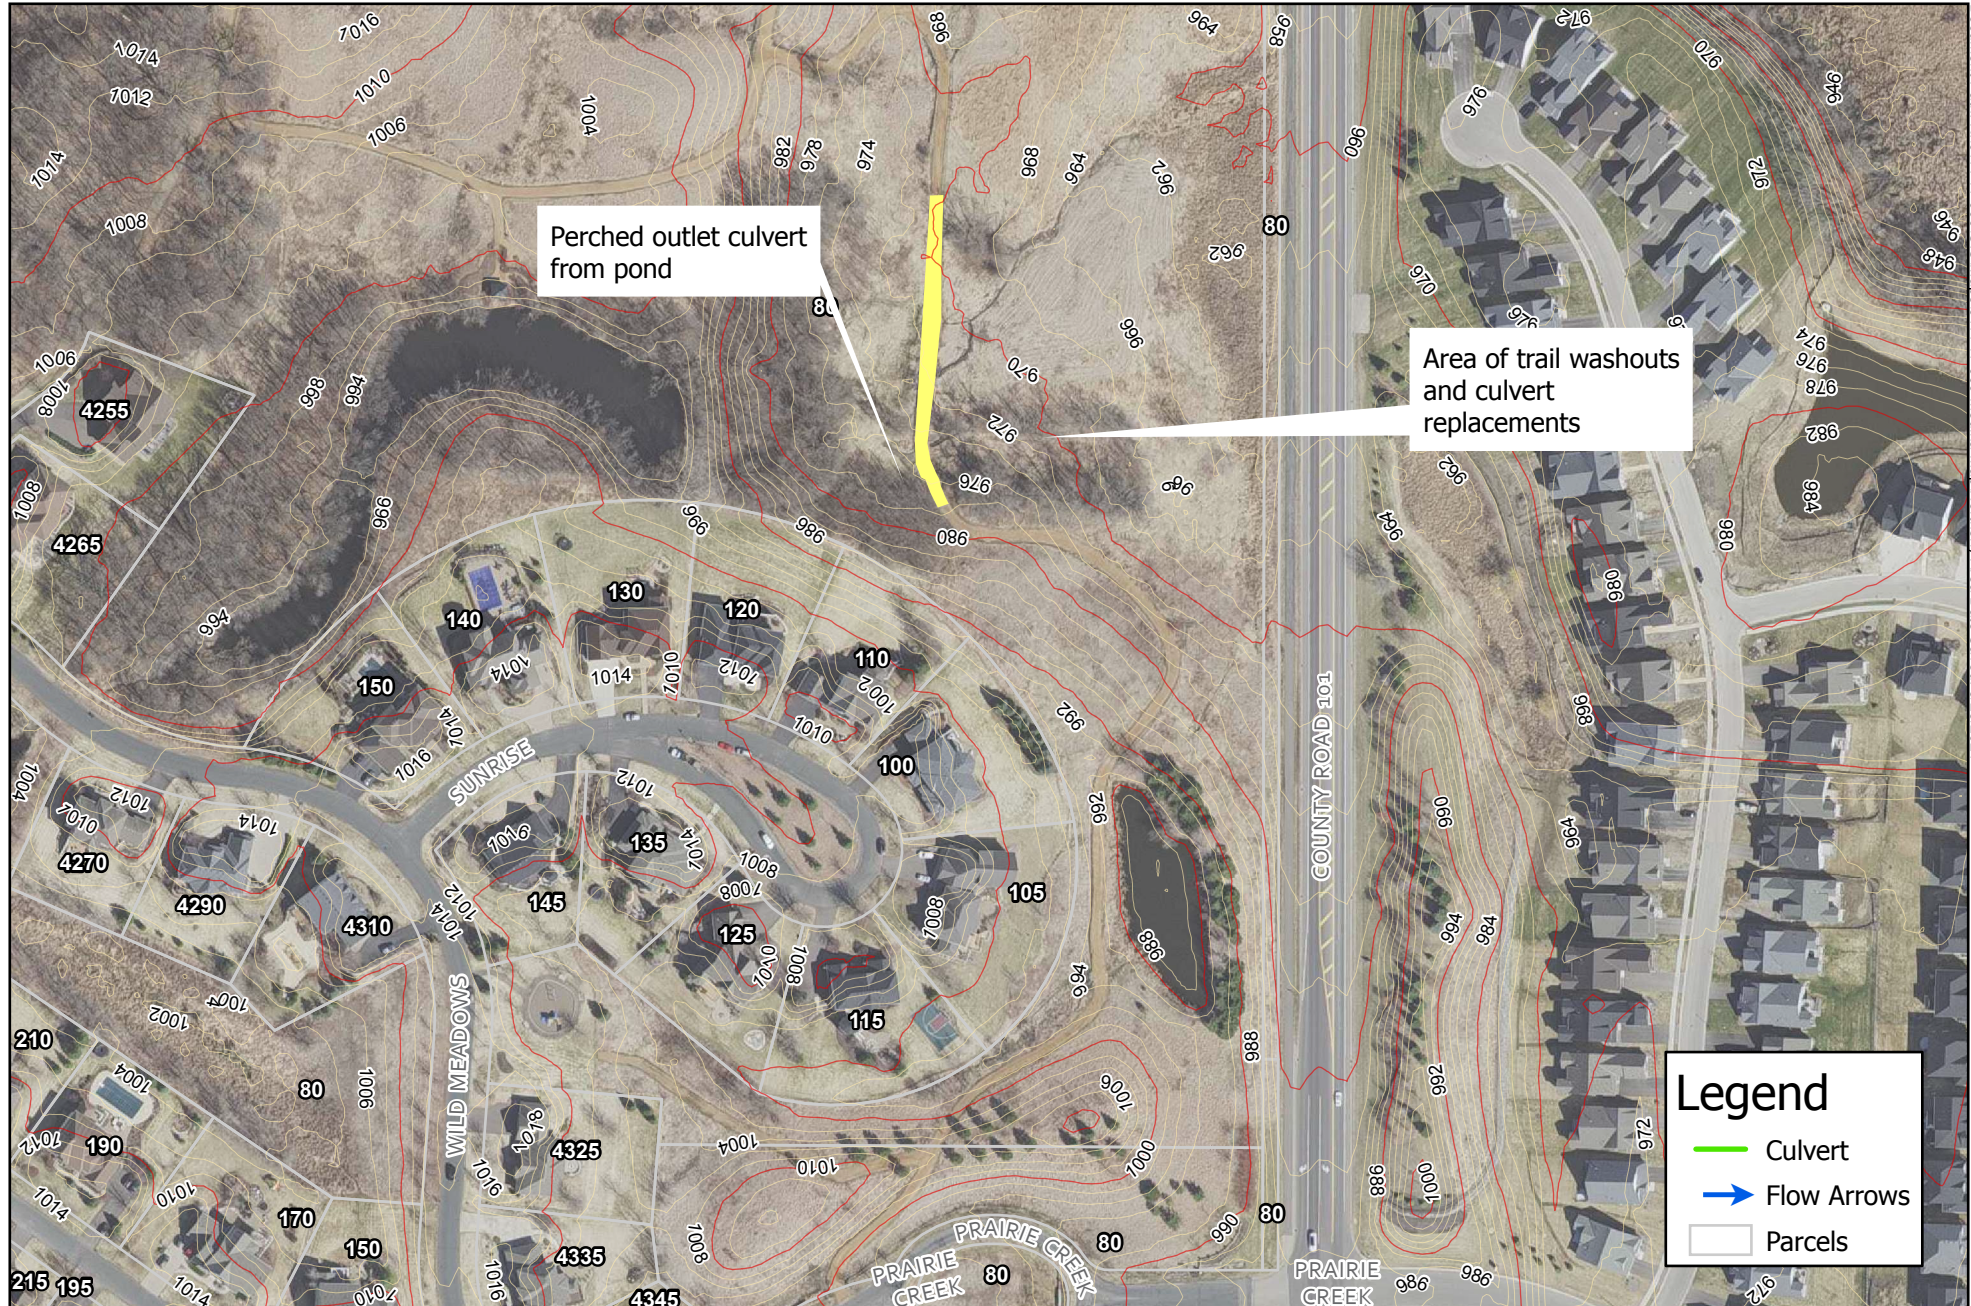
Exhibit A - Northerly Area

The Northerly Area shown in **Exhibit A** generally consists of the gravel trail located east and north of Sunrise Ct. This trail is comprised of crushed limestone and provides resident access to nature areas north and east of the Wild Meadows development. The original (as-built) condition was a woodchip trail with periodic CMP culverts conveying offsite runoff under the trail. Over the course of several years, and particularly over the last few years, runoff from the west would flow over the trail which lead to multiple culvert washouts and trail erosion.

The primary contributing drainage to the trail area is the upstream outlet/culvert from the pond. This outlet pipe is perched above the downstream grade (appears to stick out of the ground) and currently causing erosion in and around the outfall.

WSB observed and learned of the following modifications/repairs made to the system. The HOA dug small, approximately six-inch wide ditches along the upstream sides of the trail to reduce offsite runoff from flowing over trail and conveyed this runoff to existing culverts. The HOA also replaced and added several new culverts.

These repairs have appeared to reduce the occurrence and amount of runoff flowing onto and over the trail, but increased ditch erosion has also occurred. The added culverts have appeared to reduce occurrence of overtopping, though some of the new and/or existing culverts appear to be undermined; some culverts may also have seepage issues.

Given the elevation difference of approximately 20 feet from the wetland area up to the pond, it is not reasonable to consider the trail work has had any impact on the flow conveyance from the perched pond or nearby yards.

The modifications in this area are not considered to have had a consequential effect on the stormwater treatment train for this area. The changes primarily affected flow conveyance and not water quality.

- Reinstall culverts with the undermining issues utilizing using proper bedding and water-tight seepage prevention measures.
- At the perched outlet pipe location, survey this area and evaluate alternatives for addressing the perched outlet pipe (adding fill, lowering pipe, adding a structure,

- extending the pipe etc.) and install stabilization measures (i.e. rip-rap, permanent turf reinforcing mat, etc.) in and around the outlet area.
- As a long term improvement, consider relocating the trail closer to the outlet pipe area (upstream side of the meadow) to avoid the runoff traveling over the trail. This would require a more significant improvement in design and permitting if pursued; however, it would be a better long term solution.

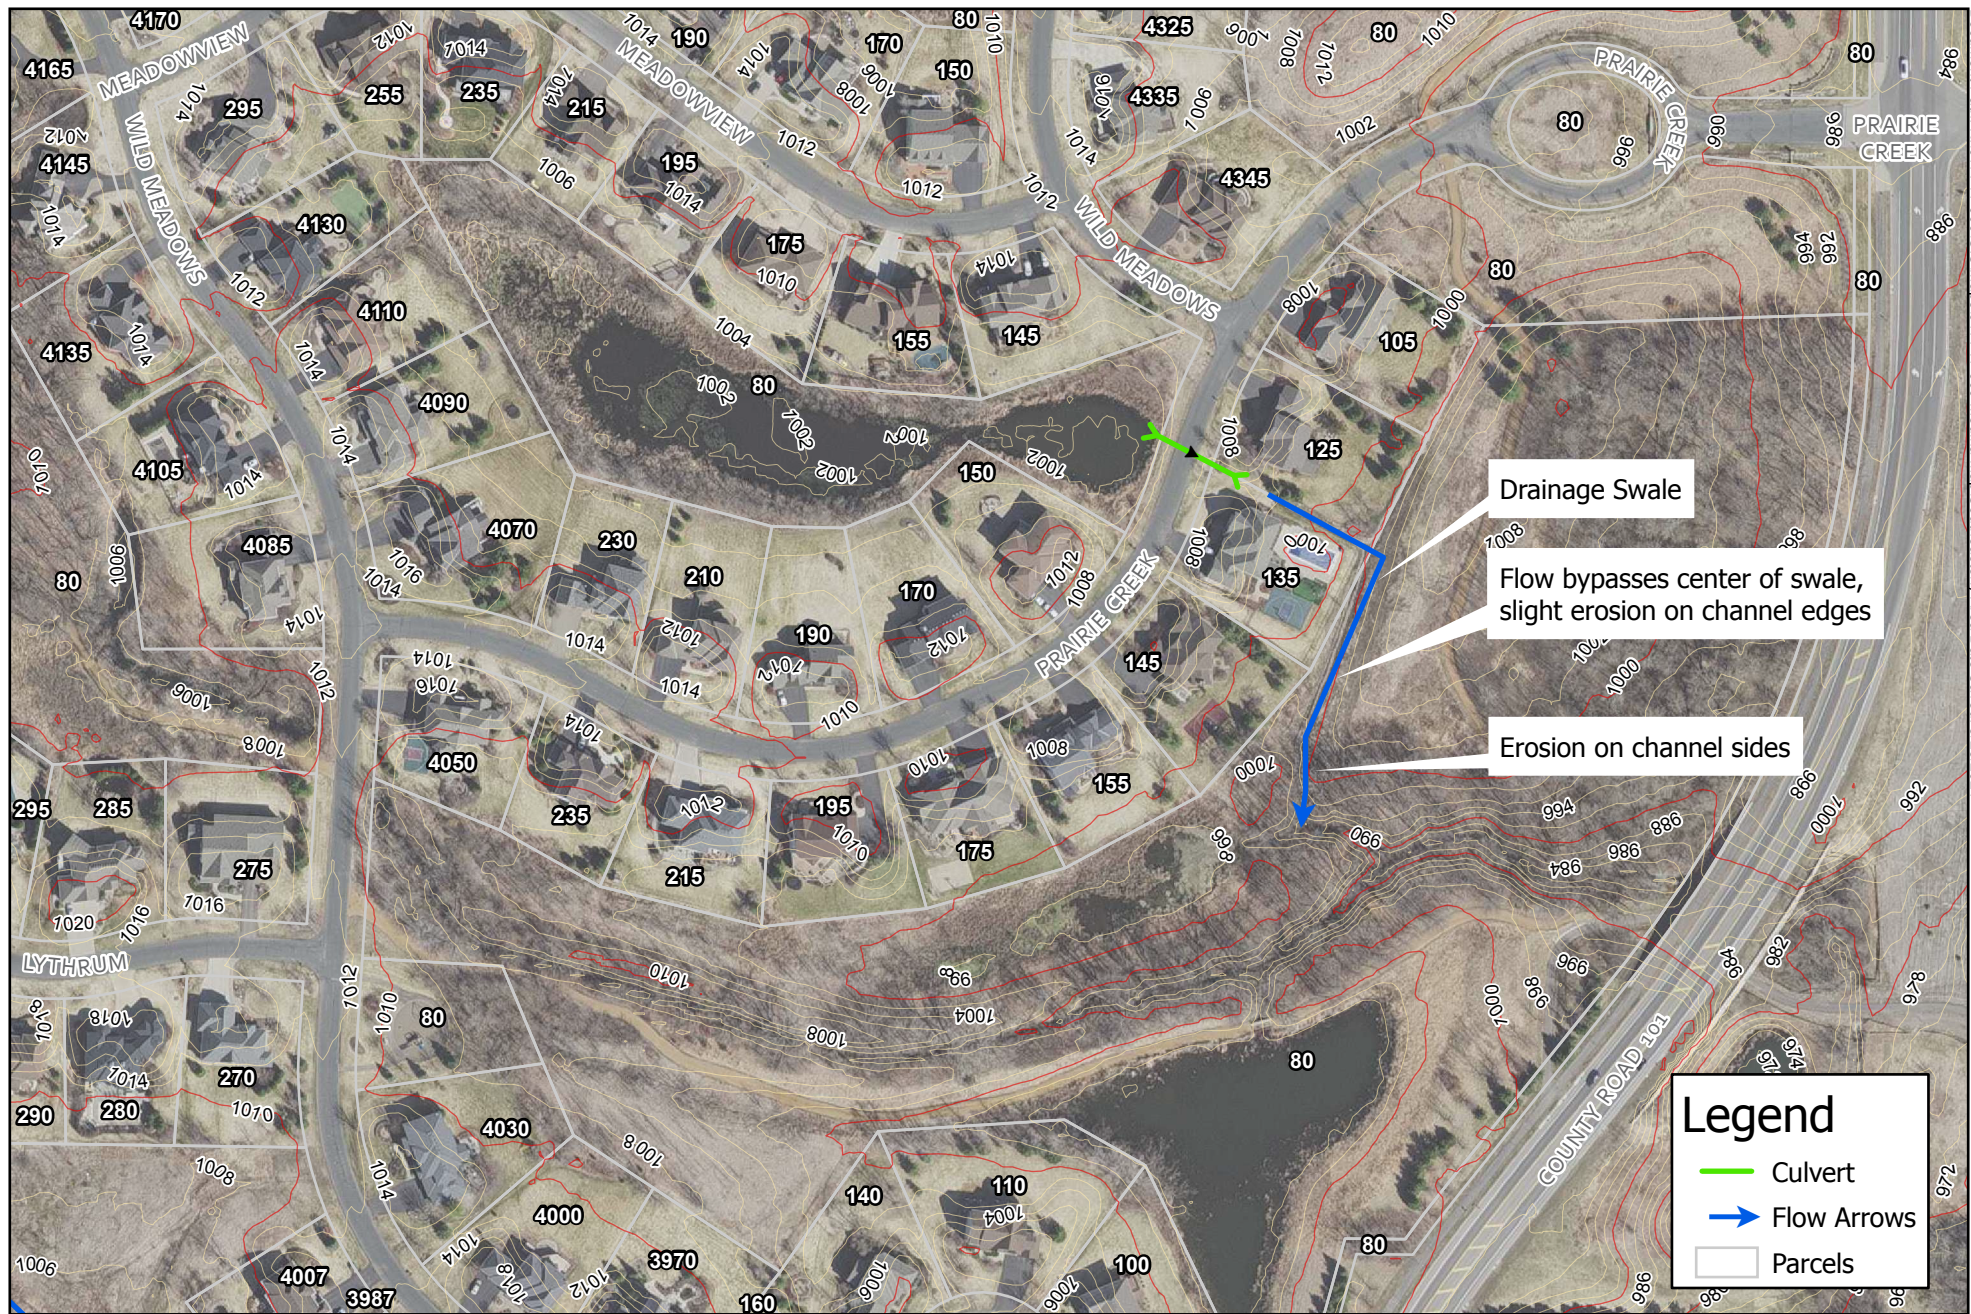
Exhibit B - Southeasterly Area

The Southeasterly Area shown in **Exhibit B** generally consists of a drainage swale between 125 and 135 Prairie Creek Rd and flowing behind lots 135 and 145 Prairie Creek Rd. This drainage swale conveys direct runoff from approximately three lots as well as inflow from an upstream pond that receives runoff from approximately 17 lots and associated roads. The original (as-built) condition was a vegetated drainage swale.

Over the last few years, vegetation, including dense cattails, established themselves within the swale causing standing water and restricting flow within the swale. Runoff had encroached into backyards and caused saturated conditions. During previous large storm events, rear yard flooding occurred and extended up to and above the low floor elevation of one home threatening to encroach into the home.

WSB observed and learned of the following modifications/repairs made to the system. To address these issues, the HOA removed vegetation in the swale, widened and regraded, and added 1-2" diameter river rock along swale bottom to reduce vegetation growth and promote flow. Based on HOA knowledge, this repair has reduced the occurrence of standing water and back-ups in the swale.

With respect to water quality treatment, the removal of vegetation slightly reduces the phosphorus removal but given the length and geometry of the swale, it is not expected that the removal of the vegetation will have a significant direct impact on water quality. This conclusion is supported by a very high level assessment of removal efficiencies of swale using the MIDS Calculator. Changing the Manning's roughness value of the swale from vegetation (0.035) to the equivalent of small rocks (~0.02) does not have a sizeable impact on TP or TSS removals. Additionally, most of the flow through this swale comes from the upstream sedimentation pond, which provides the majority of TP and TSS removal.

The changes to the swale did however appear to have resulted in faster velocities in the channel and may have contributed to erosion along downstream side slopes. In some locations the river rock has been bypassed by the flow channel and has further contributed to erosion and sediment loading downstream.

- Repair the downstream portion of the rock swale, where the flow has bypassed the rocks to the side and begun to erode the side slopes. The repair effort should include

regrading to achieve a concave shape with the centerline being at least six inches below the sides.

- Stabilize the eroded side-slopes beyond the end of the rock swale (approximately 30 feet) down the ravine where the slope steepens. Options for protecting the side slopes should consider the lack of sunlight and vegetated understory. Some grading may be required to ensure the flow area is not restricted due to the addition of rip rap or other energy dissipation methods. A few trees may also need to be removed to allow for proper grading of the side slopes.

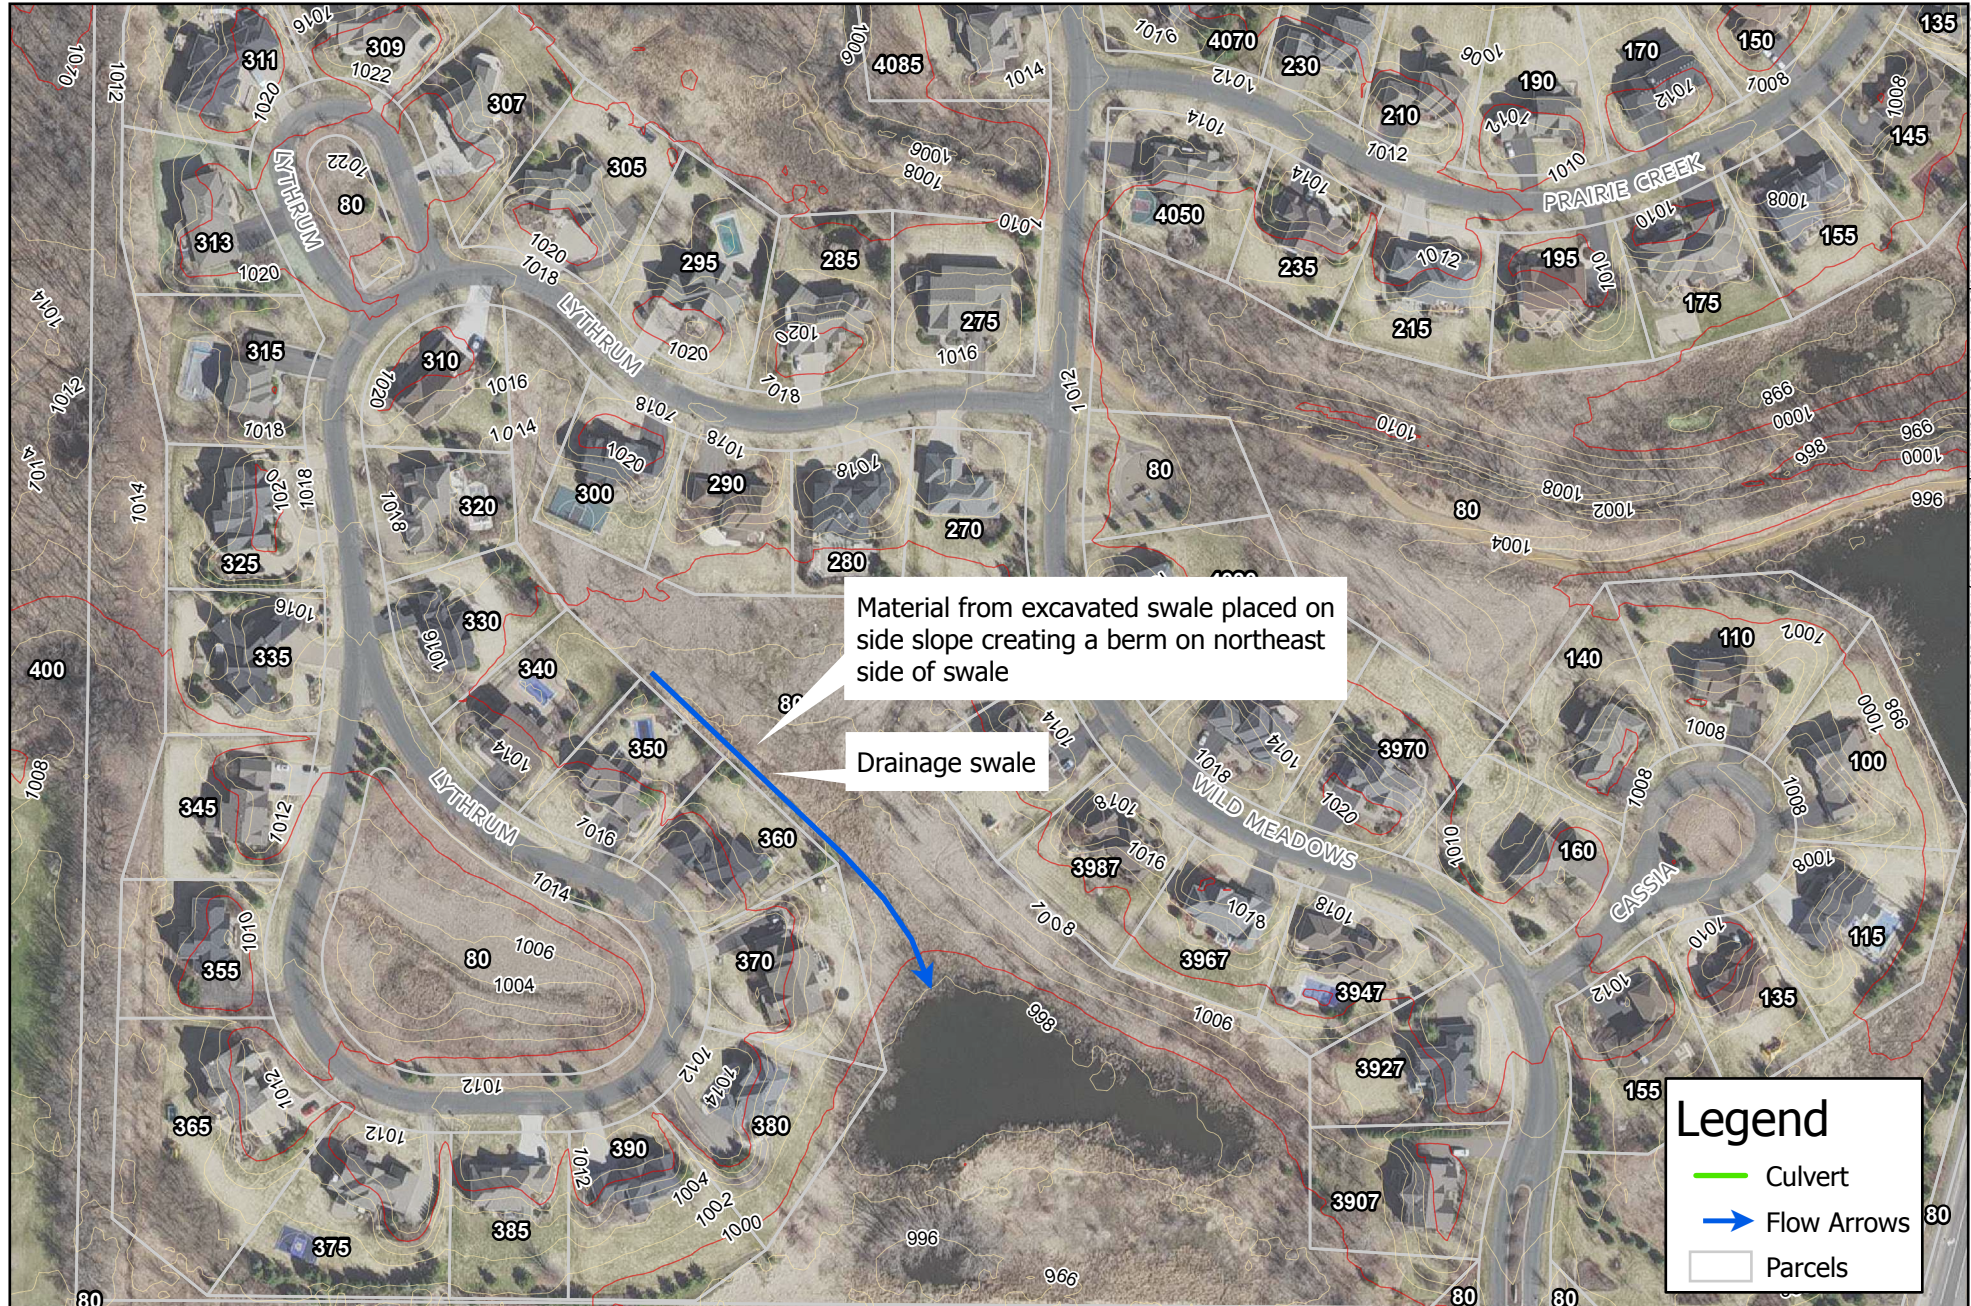
Exhibit C - Southwesterly Area

The Southwesterly Area shown in **Exhibit C** generally consists of a drainage swale located behind lots 340-370 Lythrum Ln, conveying runoff from Lythrum Ln and approximately 6 lots. The original (as-built) condition was a vegetated drainage swale.

Over the last few years, vegetation, including dense cattails, established within the swale causing standing water within the swale. Runoff encroached into backyards and caused saturated conditions.

WSB observed and learned of the following modifications/repairs made to the system. To address these issues, the HOA removed vegetation in the swale, widened and regraded, and added 1-2" diameter river rock along swale bottom to reduce vegetation growth and promote flow. Based on HOA knowledge, this repair has reduced the occurrence of standing and back-ups within the swale.

Spoils from the HOA's maintenance operations were placed in a berm on the east side of the swale area. It appeared in some locations that the berm was trapping runoff, potentially concentrating the runoff, and causing some minor erosion and/or limiting plant growth. It also appeared that some of the sediment that was removed from the swale was deposited on the north bank; the ground surface appeared to be saturated in some of these areas.

With respect to water quality treatment, the removal of vegetation slightly reduces the phosphorus removal. Given the length and geometry of the swale, it is not expected that the removal of the vegetation will have a significant direct impact on water quality. This conclusion is supported by a very high level assessment of removal efficiencies of swale using the MIDS Calculator. Changing the Manning's roughness value of the swale from vegetation (0.035) to the equivalent of small rocks (~0.02) does not have a sizeable impact on TP or TSS removals.

Given the geometry and slope of the swale, erosion issues are not anticipated due to slow velocities. Additionally, the downstream waterbody appears to provide sufficient deadpool sedimentation treatment, and the long swale and high amount of disconnected impervious still provide pretreatment.

- Remove the spoil piles/berms created when the rock swale was constructed and return slope to what was likely more of a “sheet flow” condition.
- Vegetate disturbed or other existing bare areas with approved seed mixtures.
