Rush Creek Headwaters Subwatershed Assessment Report

Prepared for:
Elm Creek Watershed Management Commission

WENCK Associates, Inc.
7500 Olson Memorial Highway
Suite 300
Golden Valley, MN 55427
Phone: 763-252-6800

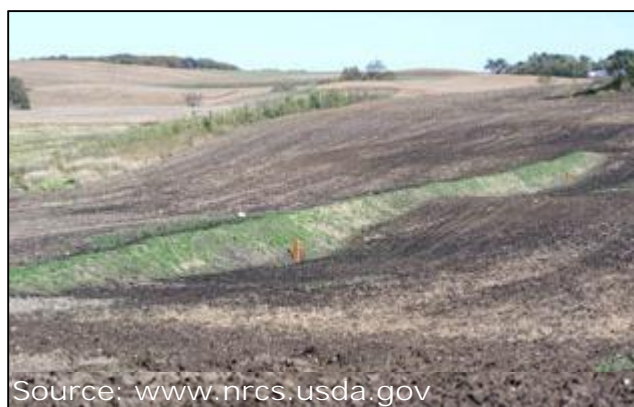
Water and Sediment Control Basin (WASCOBS)

Water and sediment control basins (WASCOBS) are small earthen ridge-and-channel embankments built across the slope of field or minor waterway to temporarily detain and release water through a piped outlet or through infiltration. They are constructed perpendicular to the flow direction and parallel to each other. Potential benefits include volume/rate control and reduction of TSS and particulate phosphorus through settling and/or infiltration. The “WASCOBS Tool” within ACPF was used to site potential locations for WASCOB berms and the area of inundation upslope of the berm. This tool utilizes calculated slopes, flow accumulation grids, and embankment height of flow pathways to determine suitable locations for these practices.

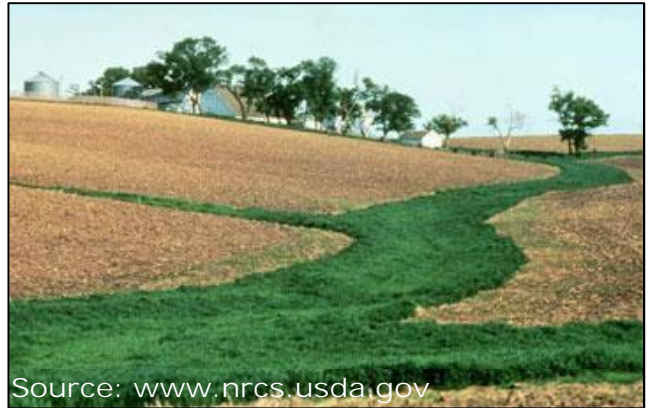
Grassed Waterway

Grassed waterways are broad, shallow constructed channels that are seeded to grass and drain water from areas of concentrated

flow. The vegetative cover in the waterway helps slow the water flow and protects the channel surface from rill and gully erosion. Water quality benefits for grass waterways include reduction of sediment and particulate phosphorus. The “Grassed Waterways Tool” within ACPF was used to site potential locations for grassed waterways in the Elm Creek Headwaters study area. This tool utilizes a user-defined stream power index (SPI) threshold to site potential locations for these practices. It should be pointed out that in many cases, grass waterways and WASCOBs can be used inter-changably depending on field/site conditions.

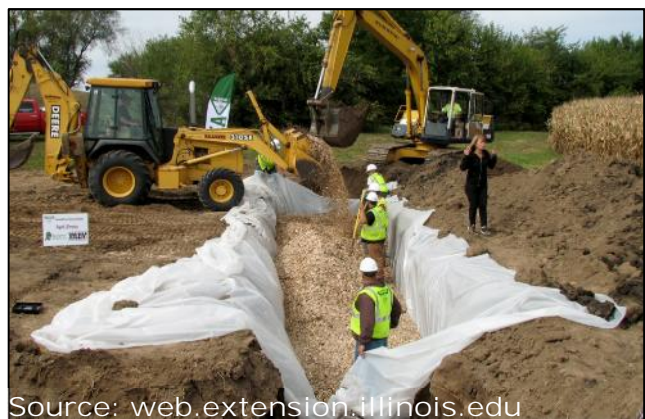
Denitrifying Bioreactor

Denitrifying bioreactors are a buried bed/wall of woodchips that receive a portion of tile drainage flows from an adjoining field. The woodchips provide a carbon source, which combined with the reducing conditions in the saturated subsurface environment, encourage naturally occurring bacteria to reduce nitrate through denitrification processes. Thus, the primary water quality benefit of these BMPs are nitrate removal, however these systems have are also efficient in removing TSS and TP. The “Edge of Field Bioreactors Tool” within ACPF was used to

site potential locations for bioreactors. The tool utilizes field boundary characteristics, flow accumulation, and an unfilled DEM to identify edge of field locations suitable for these practices.

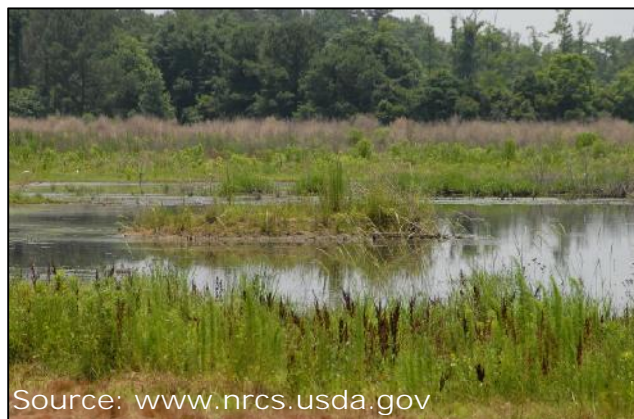
Wetland Restoration

Wetland restorations re-establish and/or repair the hydrology, plant communities and soils of a former or degraded wetland that has been drained, farmed or otherwise modified since European settlement. Restoring wetland hydrology typically involves breaking drainage tile lines, building a dike or embankment to retain water and/or installing adjustable outlets to regulate water levels. The primary benefits of wetland restorations include water storage, volume/rate control, groundwater recharge, nitrate removal, and TSS and particulate phosphorus reduction via settling. Potential sites for wetland restorations were identified using two separate tools within the ACPF toolbox – the “Nutrient Removal Wetlands Tool” and the “Depression Identification Tool.” The nutrient removal wetlands tool sites potential wetland restoration sites along collective flow pathways that are downstream of tile drained fields. The depression identification tool identifies depressions on the landscape that have poorly drained/hydric soils and are currently in agricultural production.

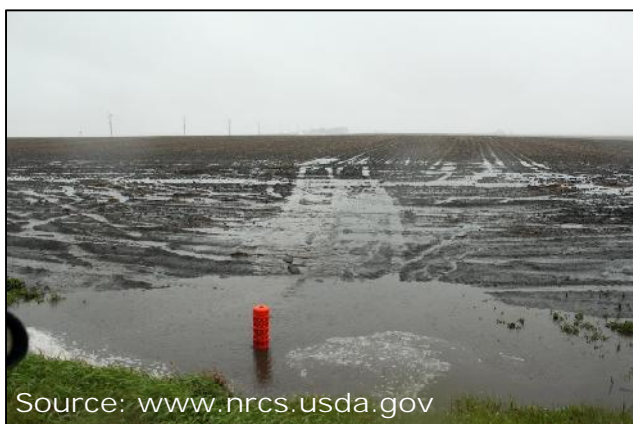
Alternative Tile Intake (ATI)

Open intakes that are flush with the surface of the ground can provide a direct conduit for sediment and nutrients to enter the tile system, which lead to ditches, streams, and rivers. Alternative tile intakes (ATIs) increase sediment trapping efficiency through increased settling time and/or filtering. They can also reduce the velocity of flow into the tile inlet. Alternative tile intakes include:

- 1) Perforated risers, such as the Hickenbottom riser;
- 2) Dense pattern tile within the isolated surface depression with a capacity equal to the open tile inlet it replaces;
- 3) Other variations include a slotted riser and addition of a vegetated buffer surrounding the inlet.

The primary benefits of ATIs include volume/rate control and TSS and particulate phosphorus reduction via settling. Potential locations for ATIs were identified using the “Depression Identification Tool” within the ACPF toolbox. This tool identifies depressions on the landscape that have poorly drained/hydric soils and are currently in agricultural production. For the purposes of this assessment, ATIs are presented as an alternative option to wetland restorations for depression areas where landowners would like to continue farming and not remove from production.

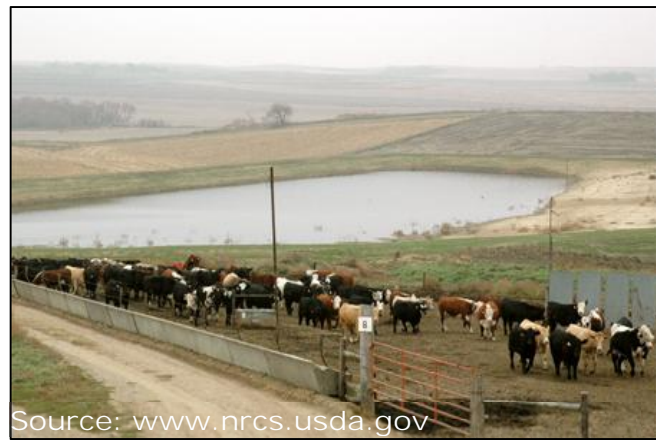
BMP options to protect surface water are typically either full containment systems or discharge runoff systems. Typically, feedlot control systems are integrated structures and practices for collecting, storing and treating livestock manure and feed wastes to reduce runoff and subsequent pollution. Examples include: lagoons, vaults or other lined impoundments, but can also include covers such as roofs, or walls and berms to prevent precipitation from entering the feedlot and subsequent run-off of mixed precipitation and manure. Typically, dairy farms have additional treatment for milkhouse waste water in addition to standard feedlot controls due to high biological oxygen demand (BOD). Other feedlot and pasture management BMPs include, but are not limited to:

-) clean water diversions = a temporary ridge or excavated channel to divert concentrated and sheet surface water, and possibly subsurface water, from or around feedlot areas with high pollutants
-) roof runoff controls = management of downspouts so that rainwater and/or other runoff water is directed away from their manure storage facilities and confined animal feeding areas.
-) settling basins = basins within or adjacent to feedlots to store and treat stormwater runoff
-) resource exclusion (animal fencing) = implementing barriers to limit/prevent animal access to stream channels. While a variety of natural materials can be used for livestock exclusion, including boulders, logs and woody vegetation, fencing is the

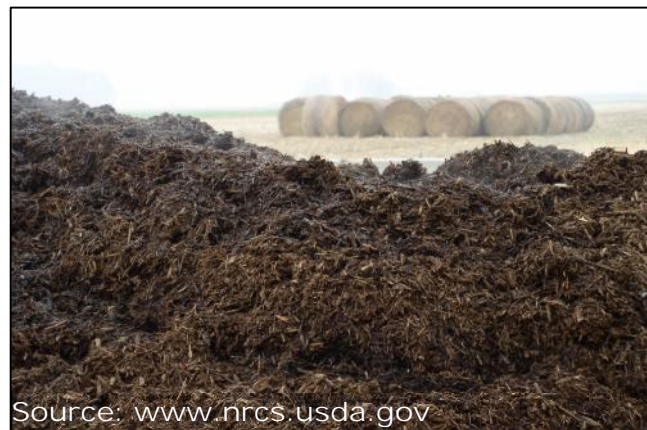
Source: www.nrcs.usda.gov

BMP options pertaining to manure management include the development and implementation of site specific manure management plans. Manure management plans pertain to both animal husbandry BMPs and site/facilities BMPs. Animal husbandry BMPs include diet modification, vaccination protocols, biosecurity, and adequate space, ventilation, and temperature that may have an impact on manure contents and movement
